# New York State Department of Transportation

## Yellow Flag NB22CTW017

**BIN: 1065318**

Location: Span 235, Girder G19 at Pier 235

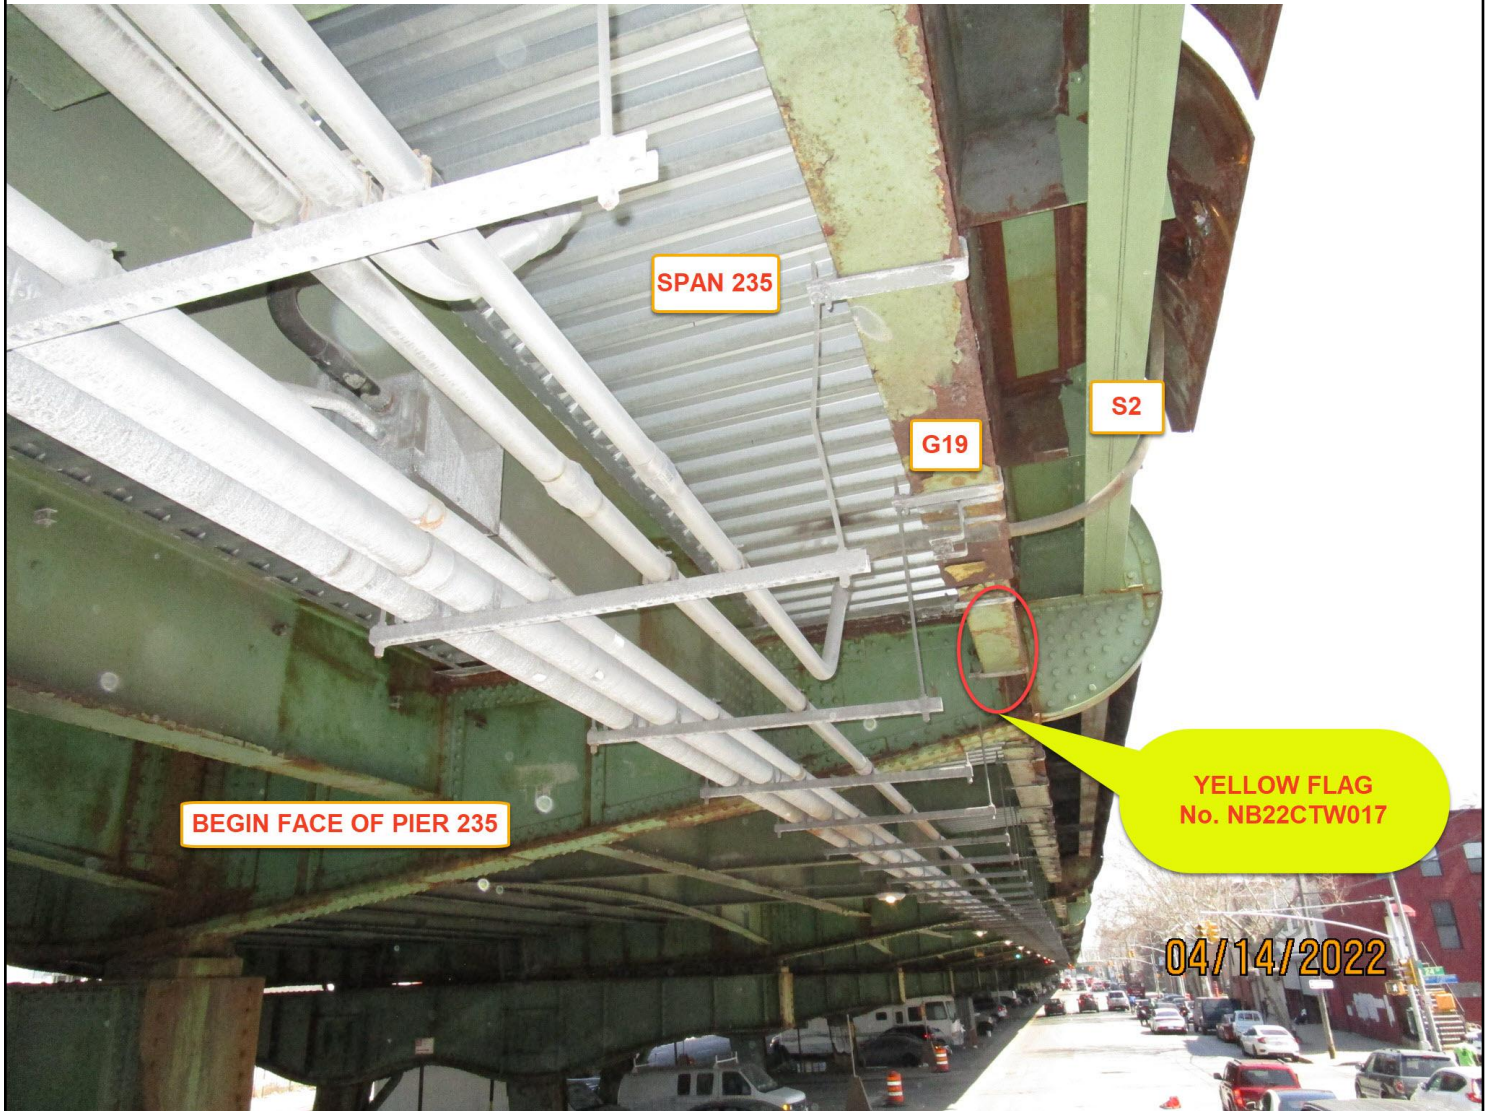
Photo Number: 1

**Attachment Description:** Span 235 Girder G19 at Pier 235 - General view of framing and Girder layout. Looking End.

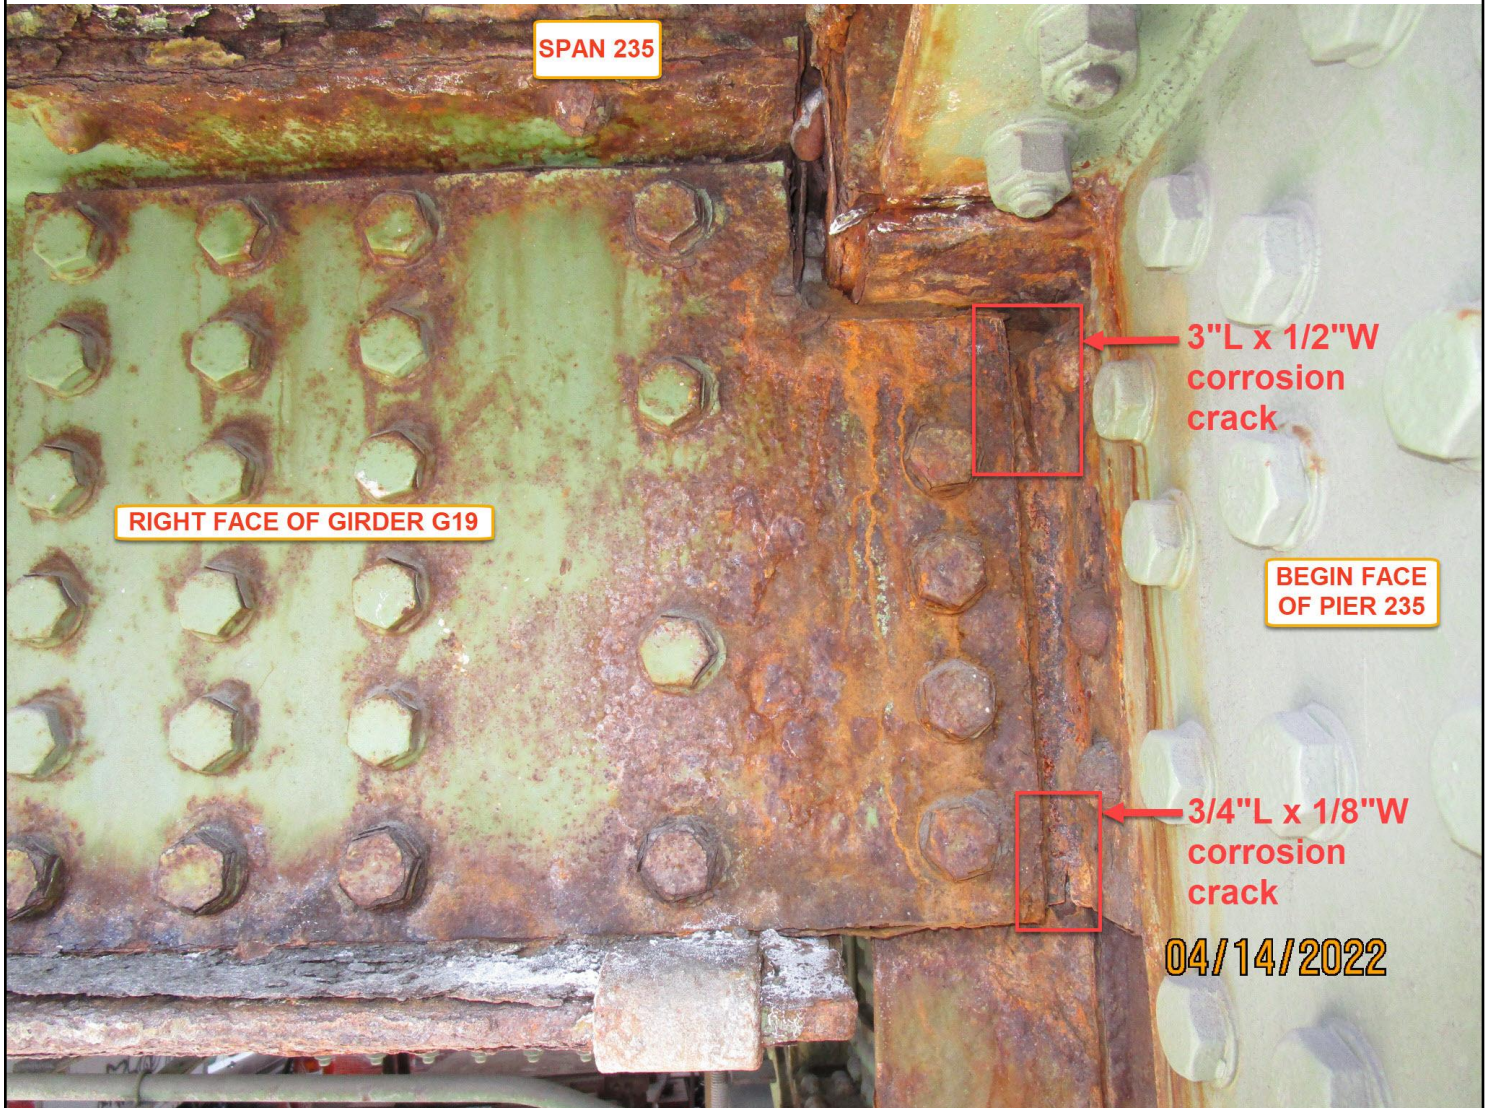
Photo Number: 2

Description: The right clip connection angle at Girder G19 connection to the pier cap at Pier 235 exhibits a 3" long x 1/2" wide vertical corrosion crack at the upper fillet section and a 3/4"L x 1/8"W corrosion crack at the lower fillet. The left vertical stiffener connection angle has localized corrosion with up to 1/8" deep section loss. These conditions are the same as reported in the last inspection.

**Attachment Description:** Span 235 Girder G19 at Pier 235 – General view of flag location. Looking Left.

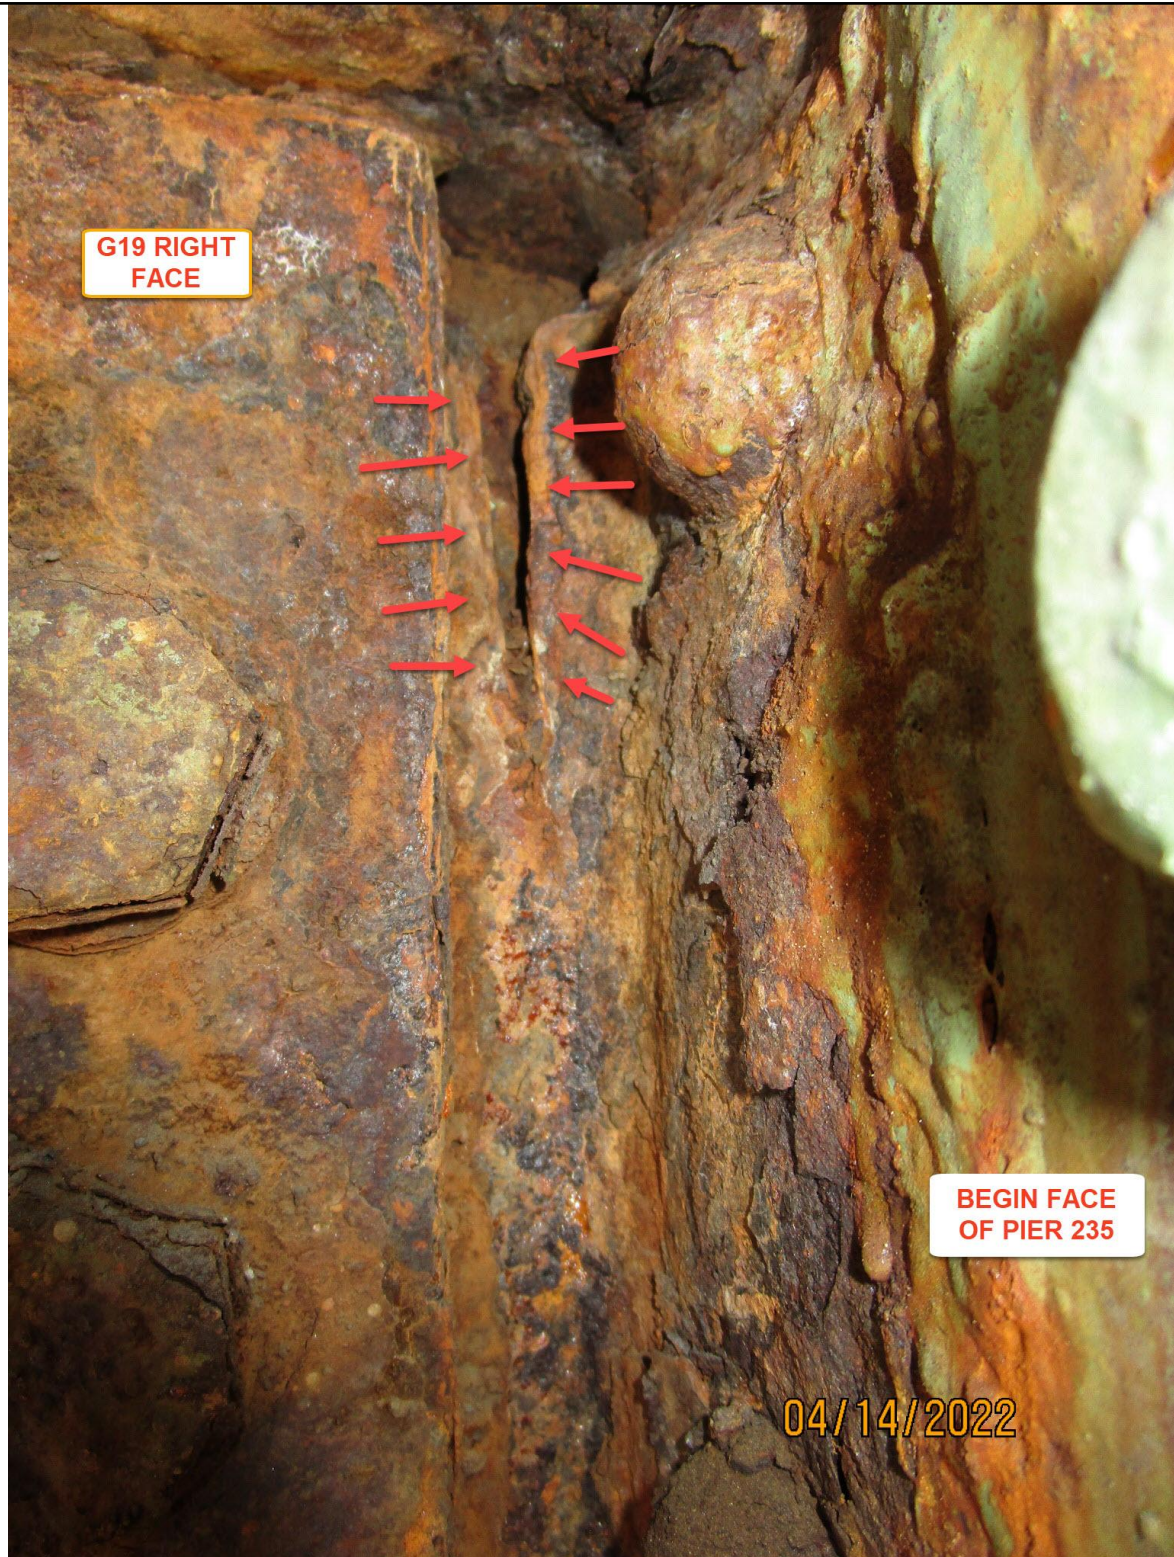
Photo Number: 3

**Attachment Description:** Span 235 Girder G19 at Pier 235 – Close-up view of 3”L x 1/2”W corrosion crack at upper fillet section of clip connection angle at right face. Looking left.

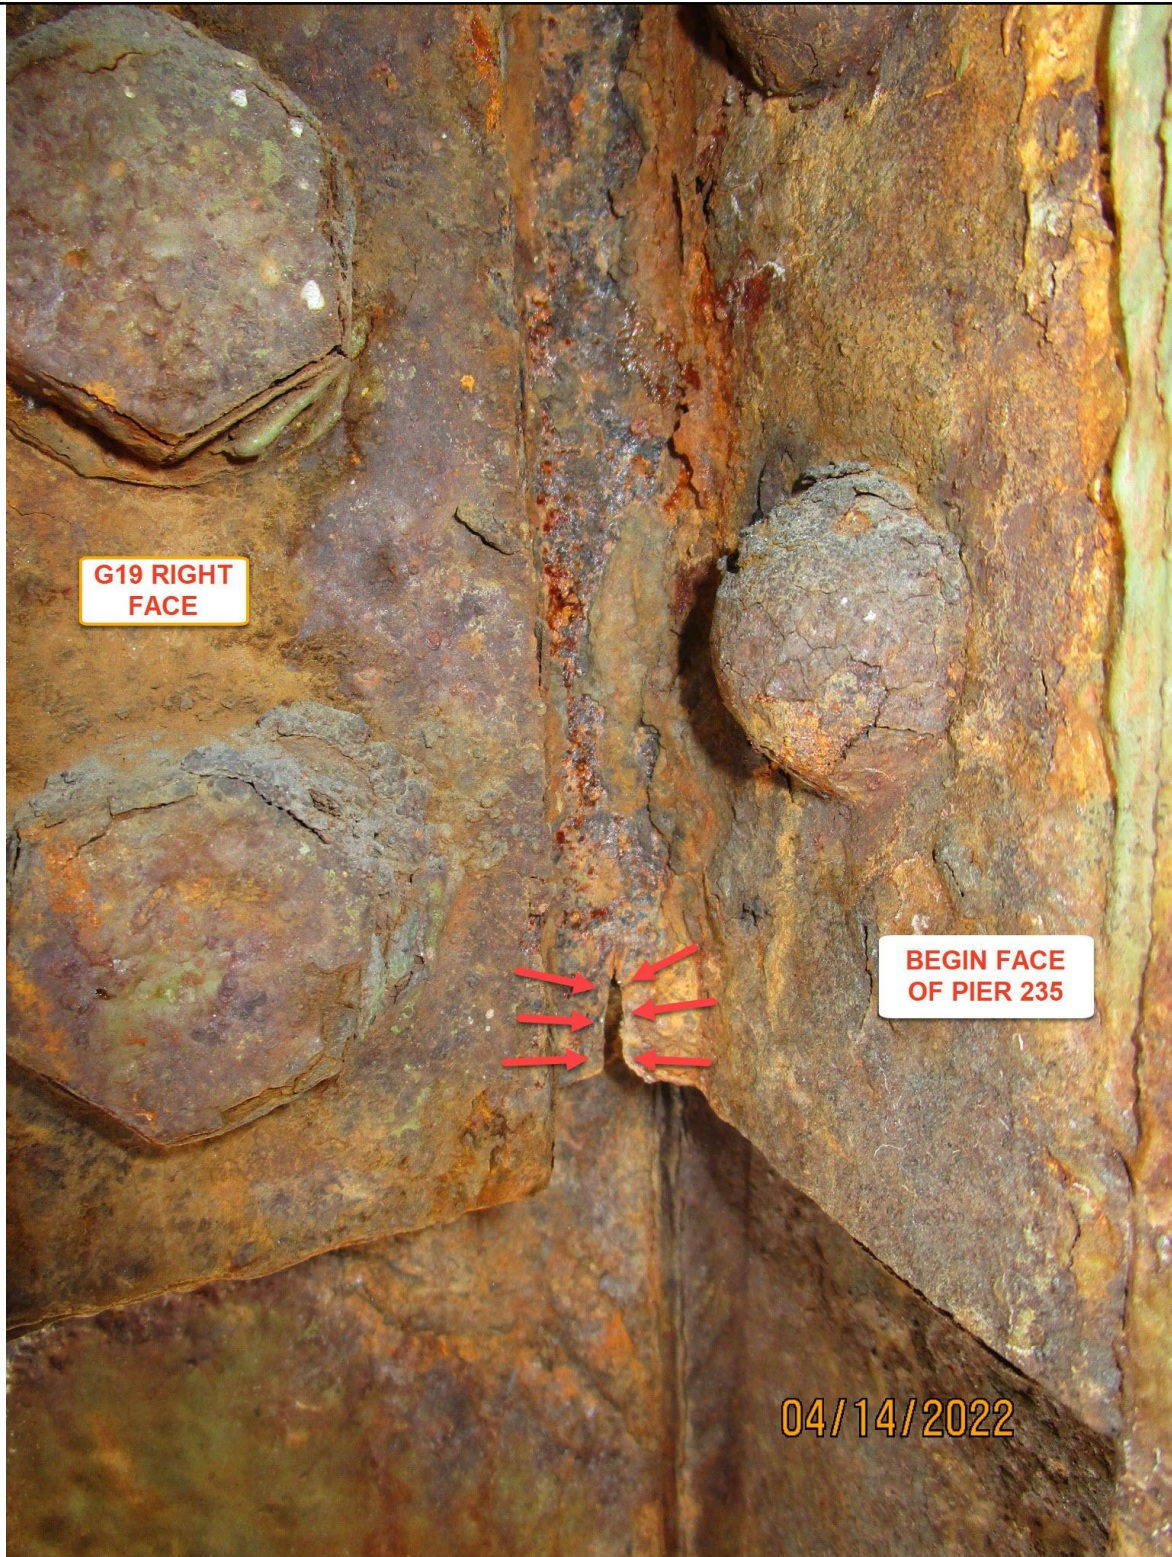
Photo Number: 4

**Attachment Description:** Span 235 Girder G19 at Pier 235 – Close-up view 3/4" L x 1/8" W corrosion crack at lower fillet section of clip connection angle at right face. Looking left.

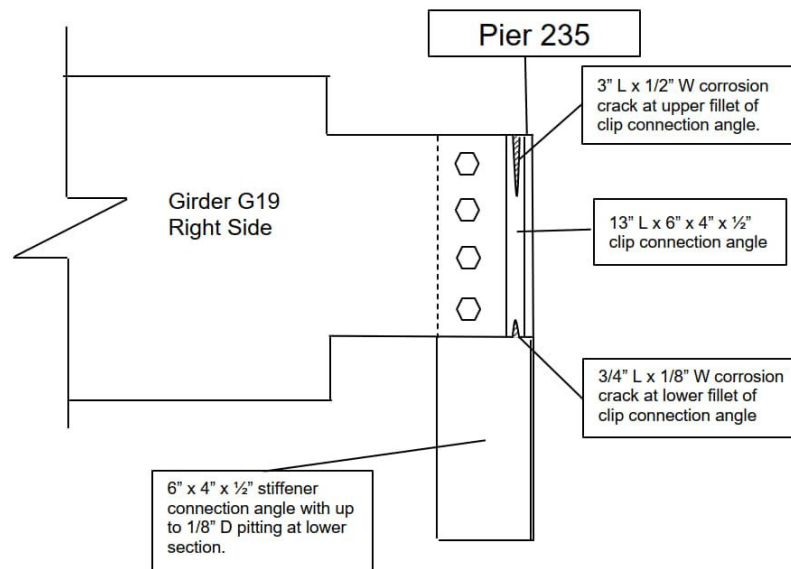
Photo Number: 5

Span 235, Girder G19 at Pier 235

Right side of Girder G19 at PIER 235 – Looking Left**Attachment Description: SN 235 G19 at Pier 235 Sketch**

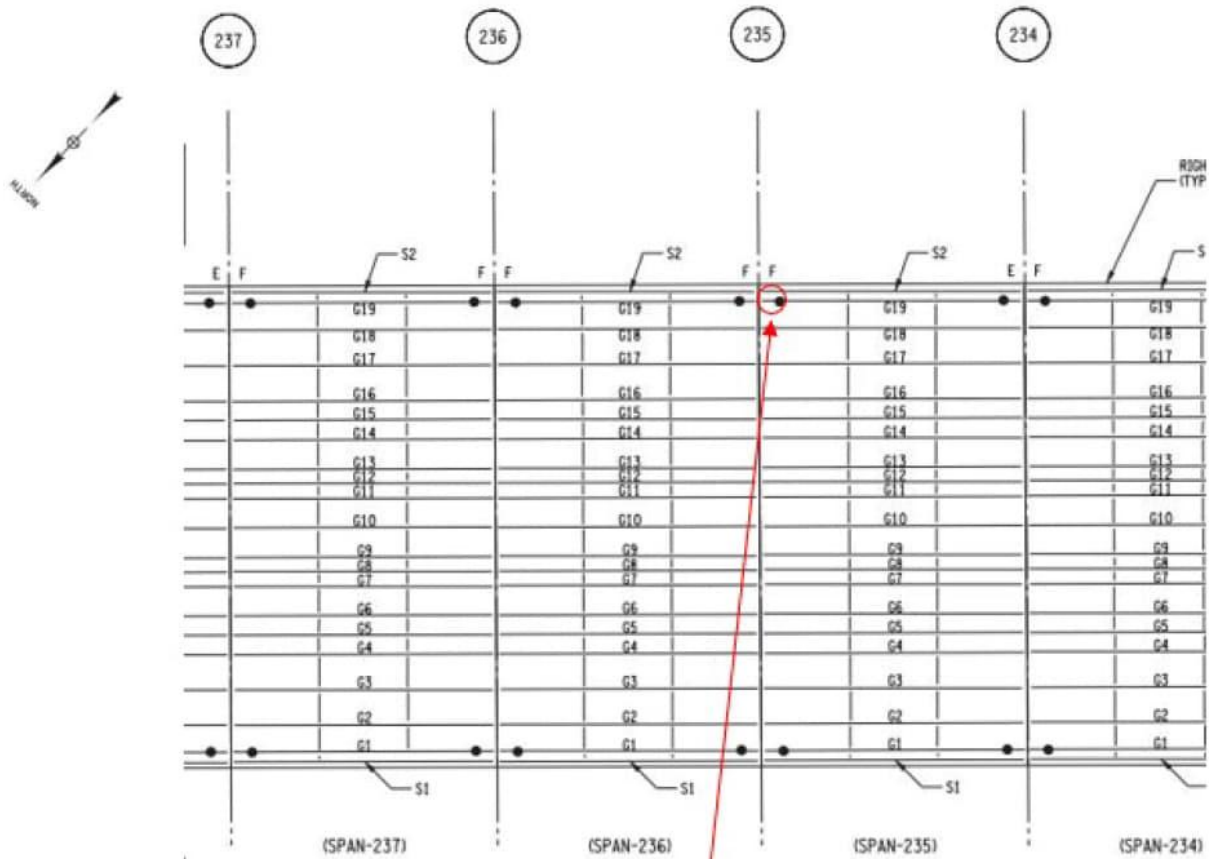
Photo Number: 6

Yellow Flag  
Location  
No. NB22CTW017

**Attachment Description: SN 235 G19 at Pier 235 Framing Plan**
